Accurate Home Inspections

Property Inspection Report

123 Sunset Street, Somerland Key, FL 33042
Inspection prepared for: Customer
Real Estate Agent: Unknown -

Date of Inspection: 4/7/2016 Time: 1:00 PM
Age of Home: 1 Year Old Size: 1,307 Sq. Ft.
Weather: Clear

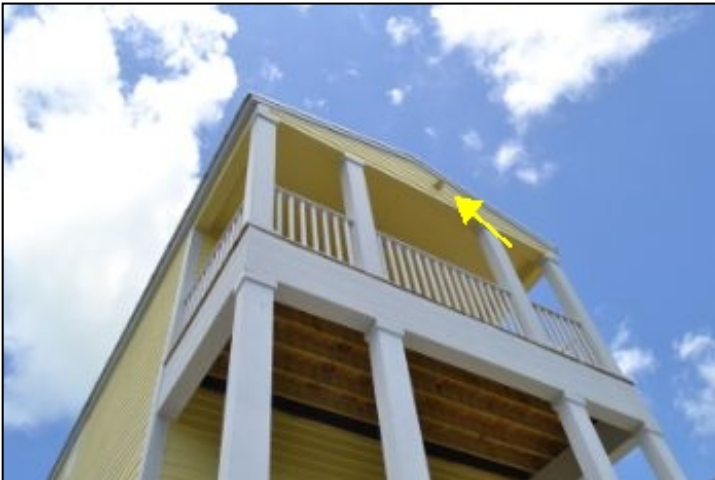
- The bathroom exhaust fan was tested and found to be in good operating condition during the inspection.
- Bath vent exhaust covers are tapped closed or damaged.

Bath exhaust is tapped shut

- **Task:**
- Repair / correct exhaust duct

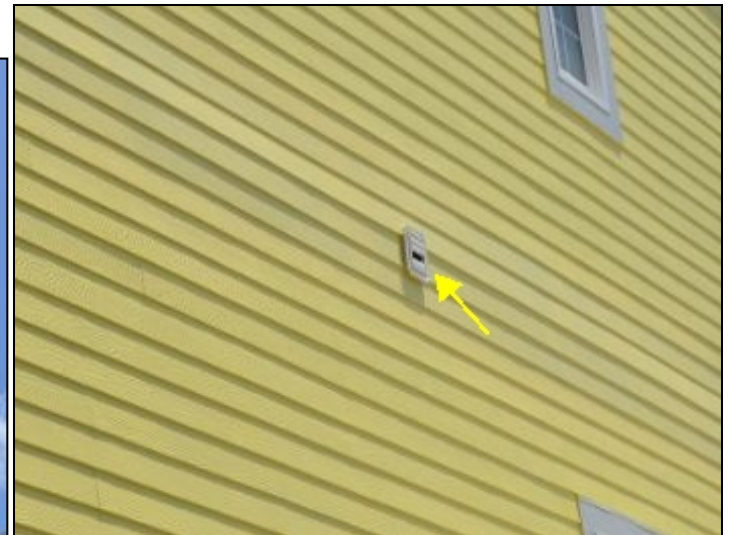
Broken cover / pest entree

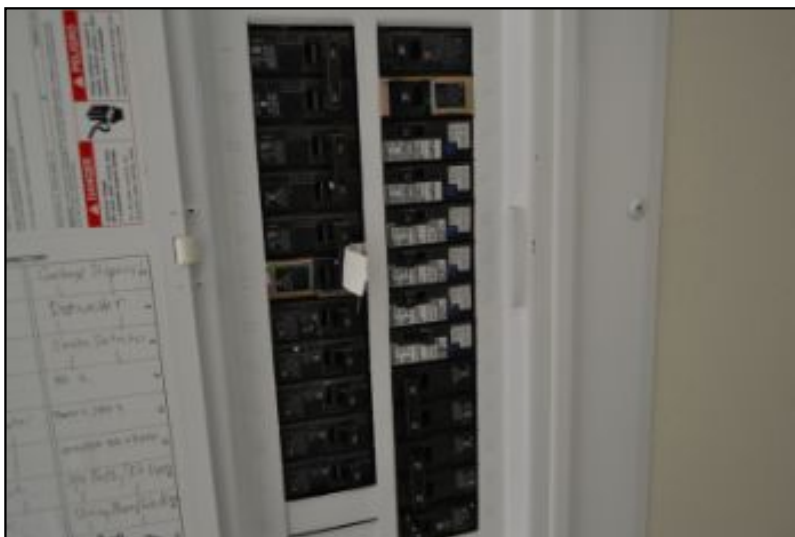
- Note: This section is primarily provided for your insurance company, most agencies want a one word description on the condition of the homes electric as well as any upgrades that have been made.
- The homes electrical system is in need of immediate repair. (Electrical shorts discovered inside the home.)

- The home has 14 single pole 120 volt breakers.
- The home has 5 double pole 240 volt breakers
- The number of reserve breaker slots or unused breakers is 6
- Two breakers were tripped and would not reset, we suspect a short circuit in a couple of areas.

Two tripped breakers would not re-set

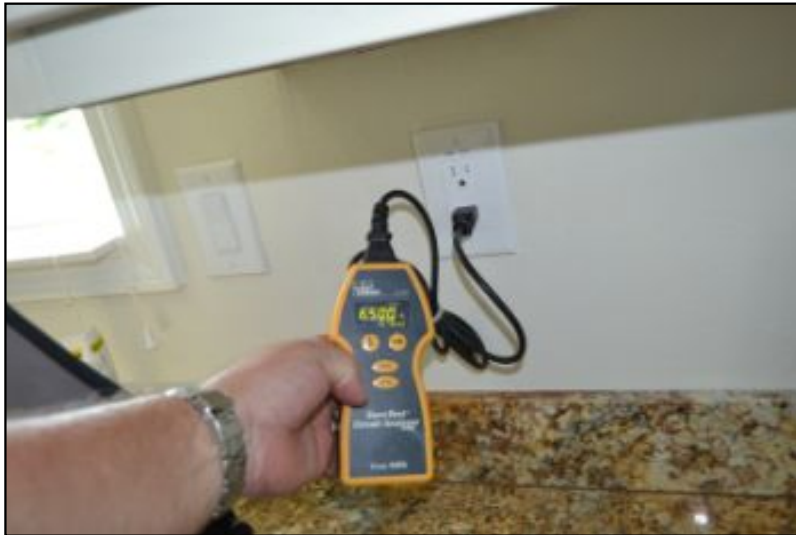
- Kitchen outlets are GFCI type however one did not pass the 6 Milliampere trip test.

Kitchen GFCI failed trip test

- **Task:**
- Repair / replace as needed.

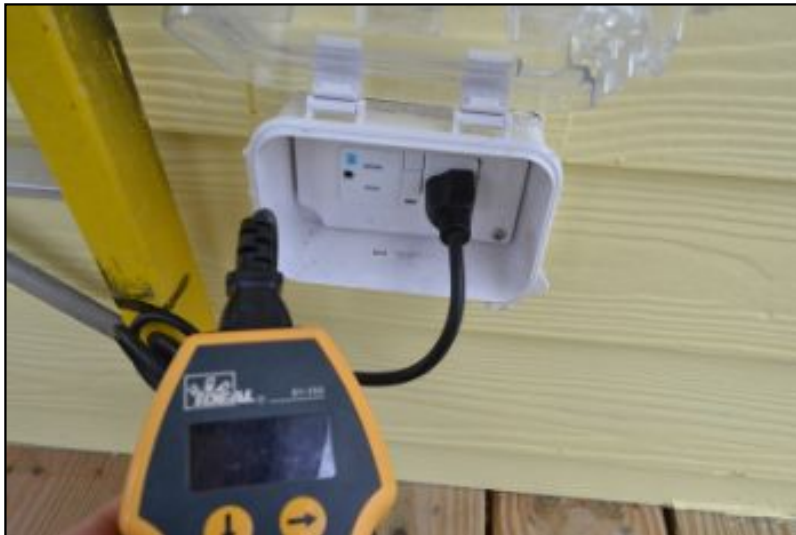
- All accessible switches were found to be operating correctly during the inspection . No visible defects observed.
- Outlets are GFCI type however one did not reset properly and has no power now.

GFCI at right of entree door would not reset.

- **Task:**
- Repair / replace as needed
- **Time Frame:**
- Immediate

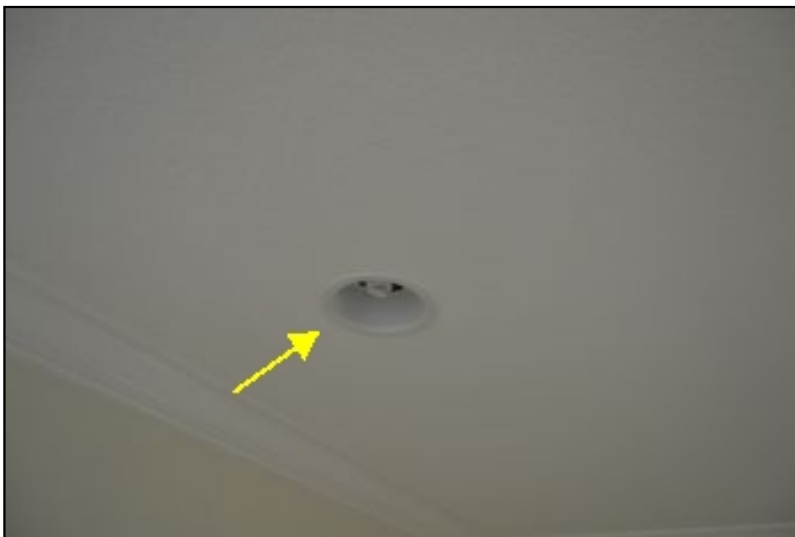
- Most lighting fixtures appear to be in good condition with no defects observed during the inspection.
- Light above the interior stairway does not have power.

Three way switch and stair light not working properly.

- Repair or replace as needed

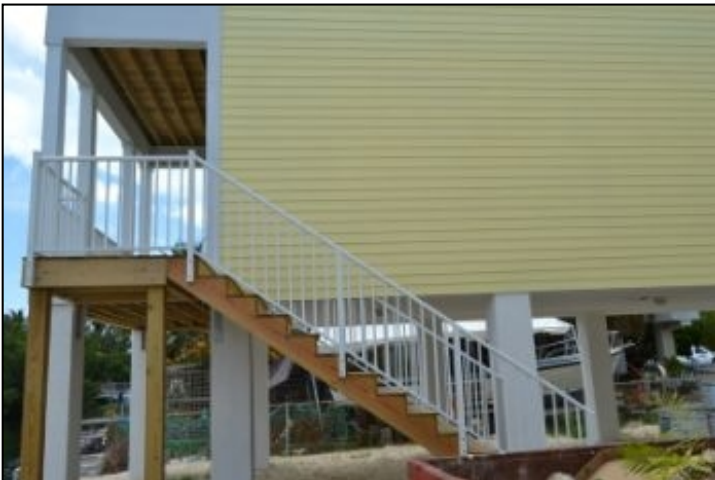
- Light fixture next to the front door does not have power.
- Light fixtures are missing above the stairway.

Missing light fixture above the stairs

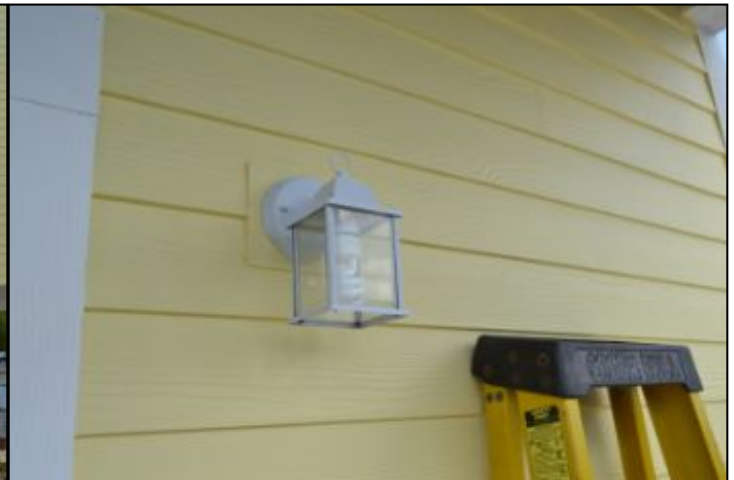
Light fixture has no power (right of entree door)

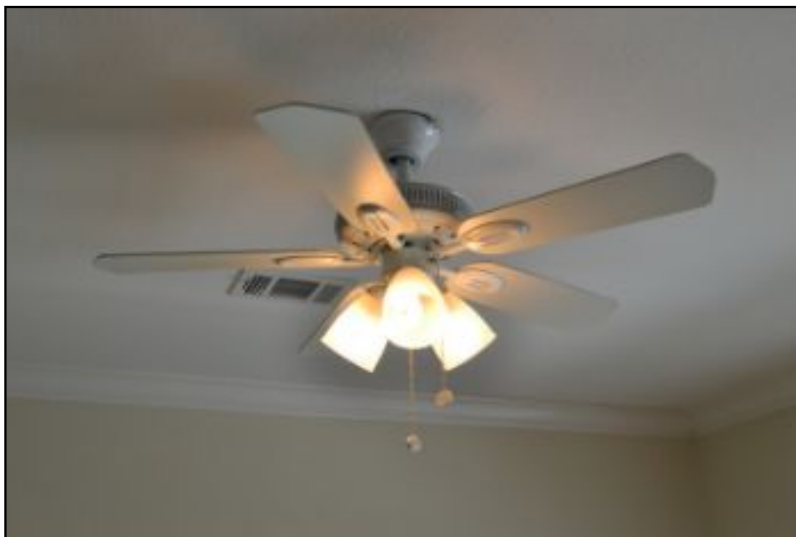
- One ceiling fan in the living had power but the fan did not operate. The other fans in the home operated normally.

Living room ceiling fan is not working properly.

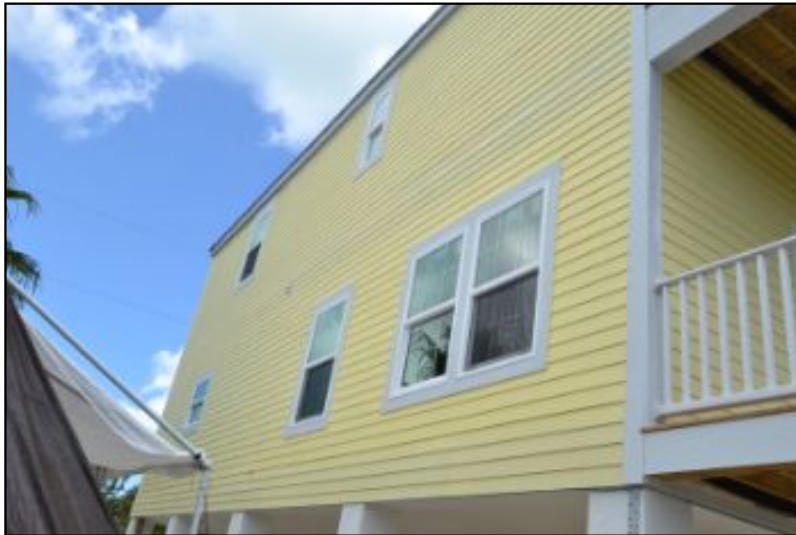
- Gutter & downspouts are missing. These are required when overhang is less than 6"

Missing gutters observed / overhang less than 6"

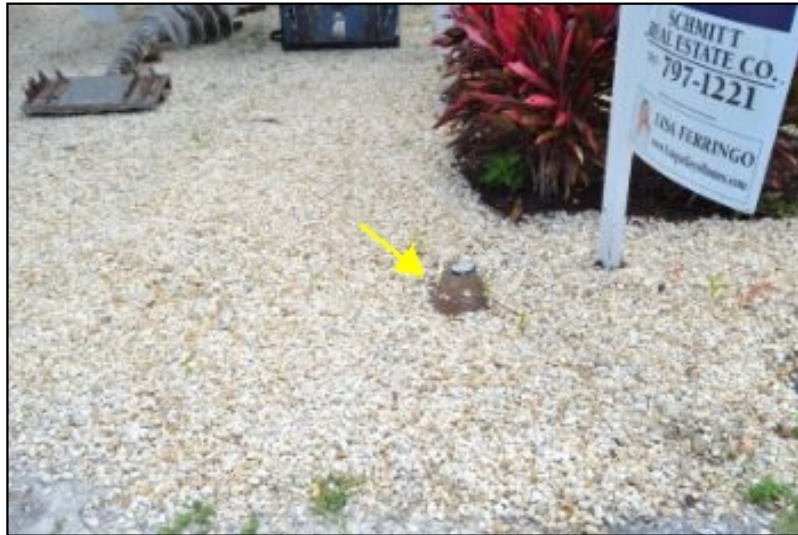
- The water meter box was not recessed even with grade.

Meter is recessed below grade

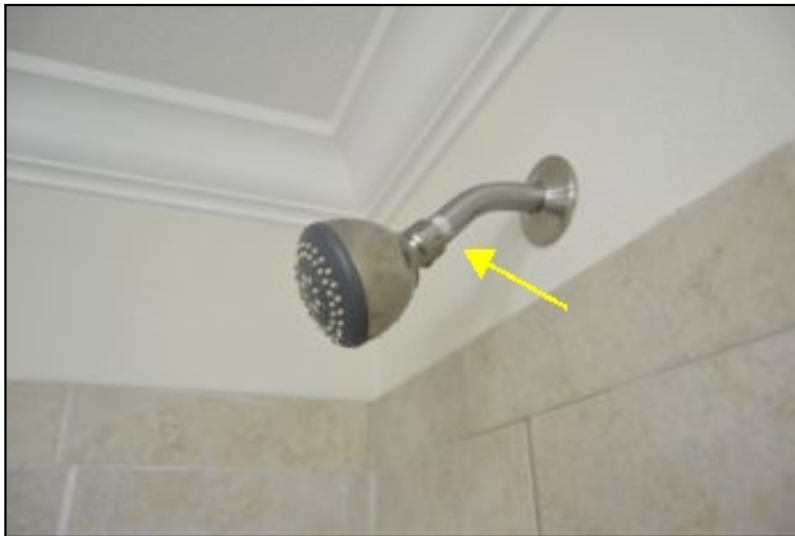
- Kitchen faucets / spray wands appear to be in good condition at the time of inspection, no defects observed.
- Bath faucets appear to be in good condition at the time of inspection, no defects observed.
- Shower head connection is leaking. Repair needed.

Leaks at shower head

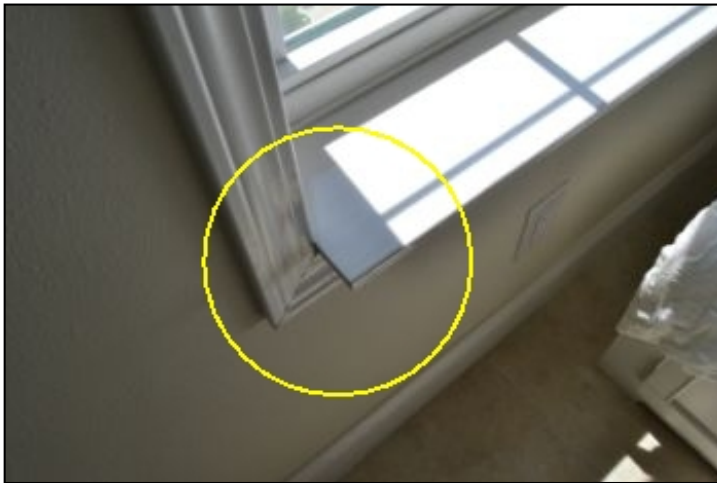
- Window sill has excessive overhang unsupported.
- Window sill heights are less than 36" and outside distance to grade is more than 30" .

Sills are too big / unsupported overhang

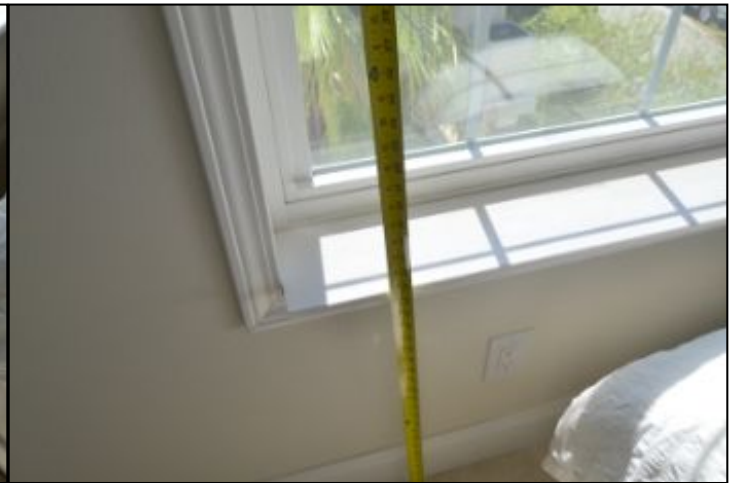
Sill heights are less than 36" / no fall protection at windows.

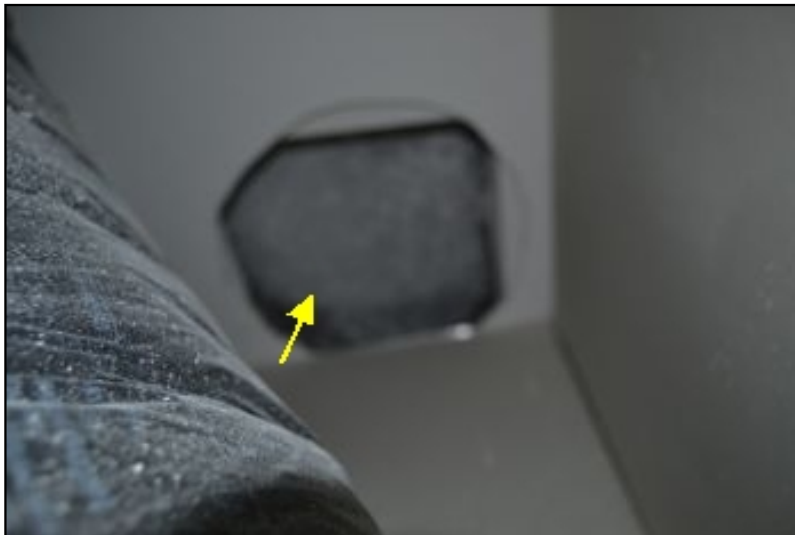
- Most closets were inspected and found to be in good / serviceable condition with no defects observed.
- AC closet ceiling needs drywall repair

Hole in AC closet ceiling

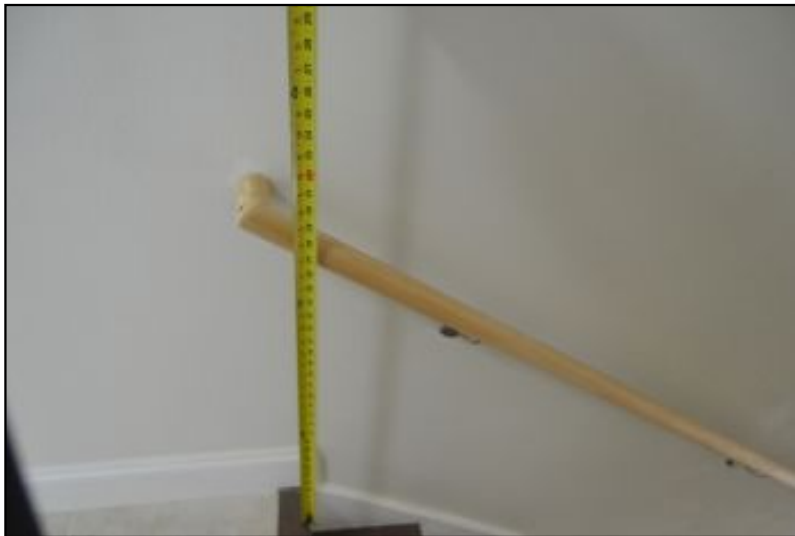
- Interior railings are too short in height.

Stair railing is mounted too low, must be 34"-38"

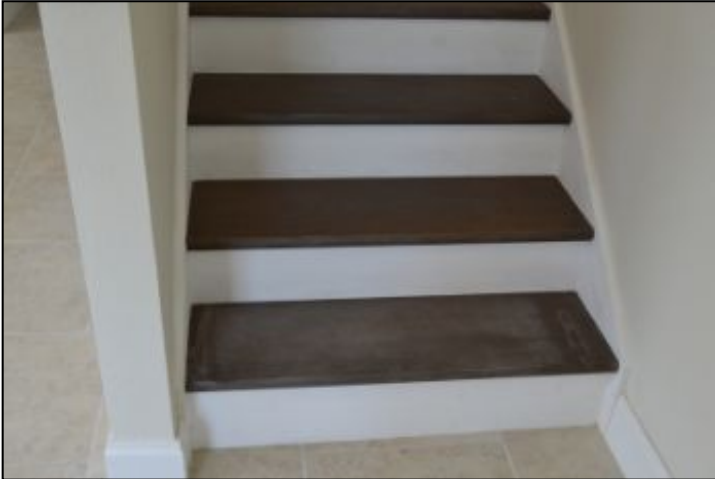
Damaged tread finish

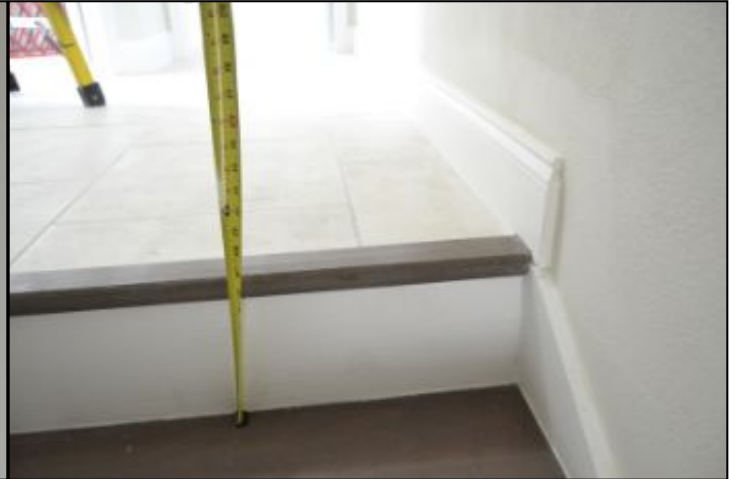
- Interior stairs have uneven step rises.

Rise is too tall at top of steps

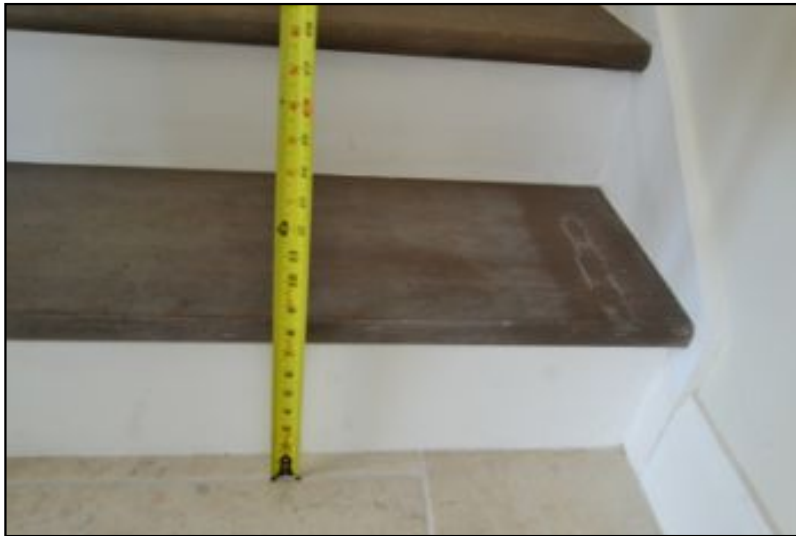
Rise is too tall at bottom of steps

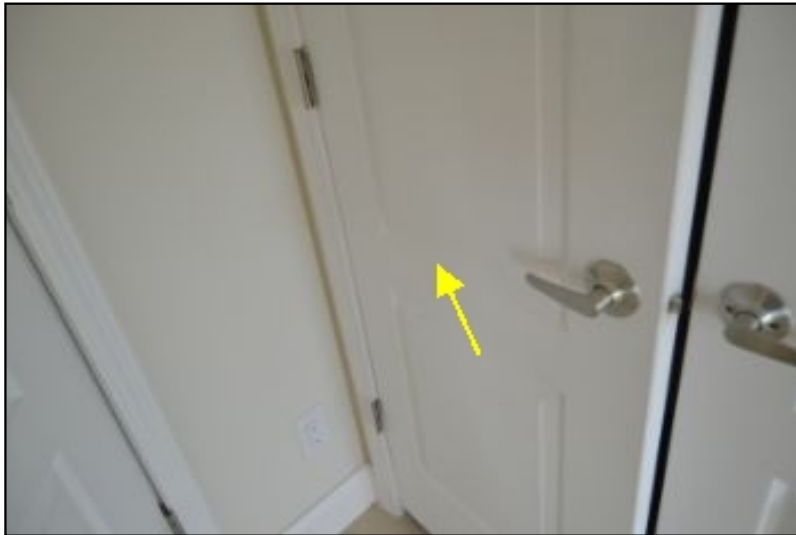
• The interior door units were inspected for fit and function and found to be in good condition, however some adjustment needed at master bedroom closet doors.

Hinge bound closet doors

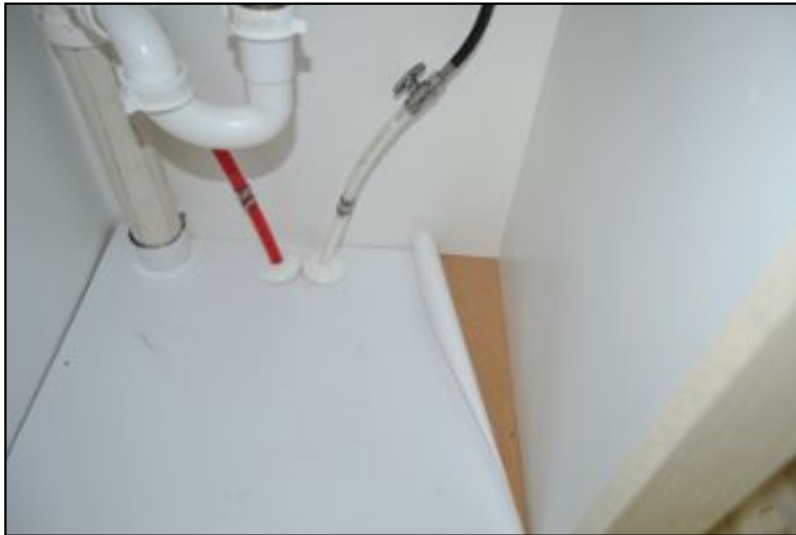
- The cabinets were inspected for fit and function and found to be in good condition. However some delamination observed at base shelf

Delamination at bath cabinet

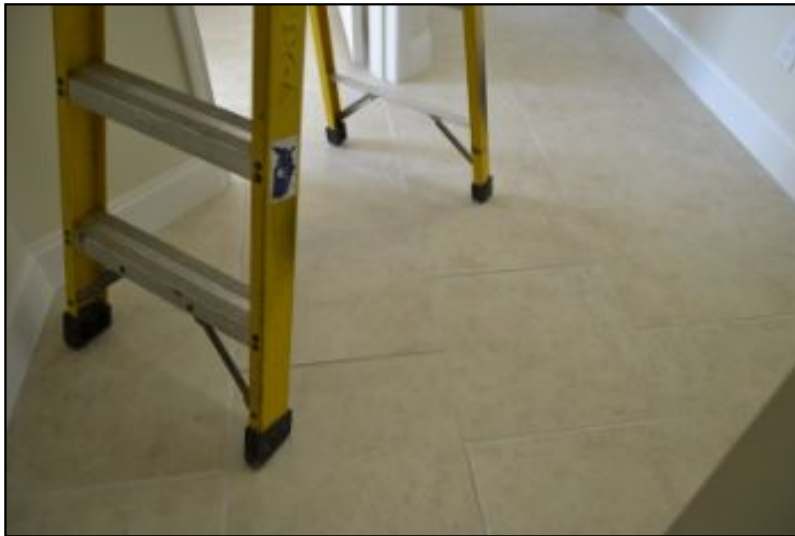
- The visible accessible areas of flooring were inspected and found to be in good condition with some minor exceptions:
- Upper level hall Flooring is not even / level

Uneven floor tiles

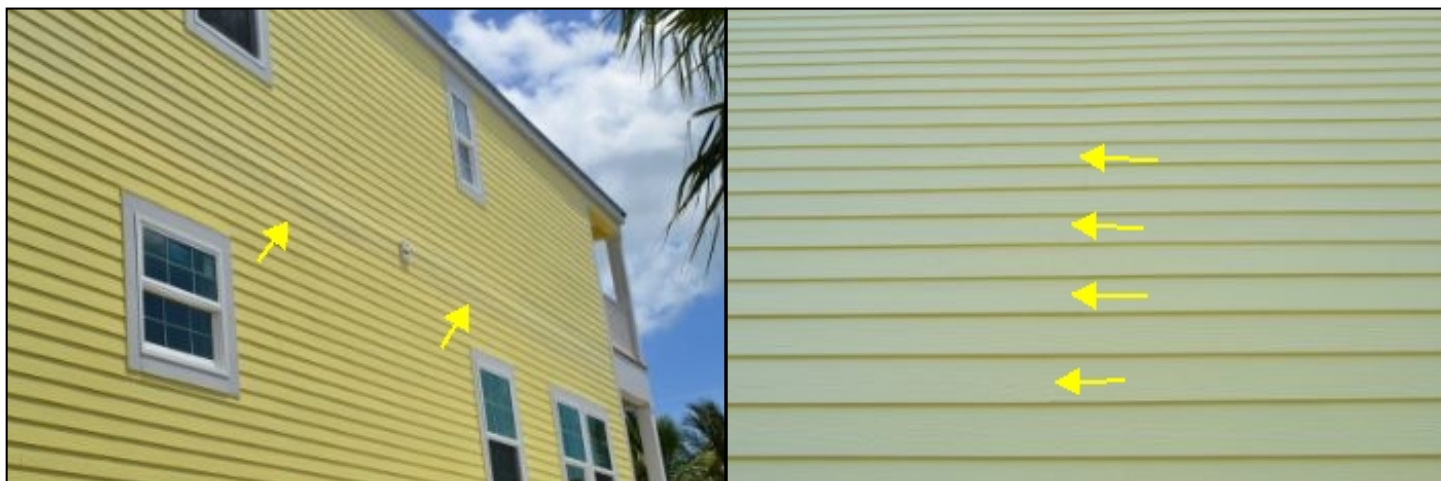
- The exterior siding / veneer was found to be in fair condition in most areas. Some visible unevenness observed on the right side of the home.
- The Hardie Board siding was improperly installed. Butt joints are not properly staggered between courses.

Uneven wall surface

Butt joints are stacked rather than staggered

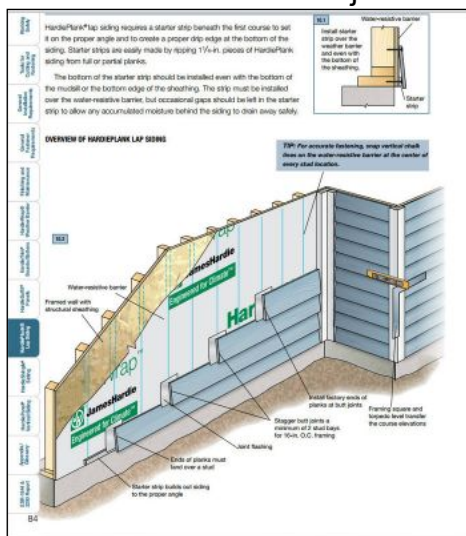
Required staggering of joints 32" apart

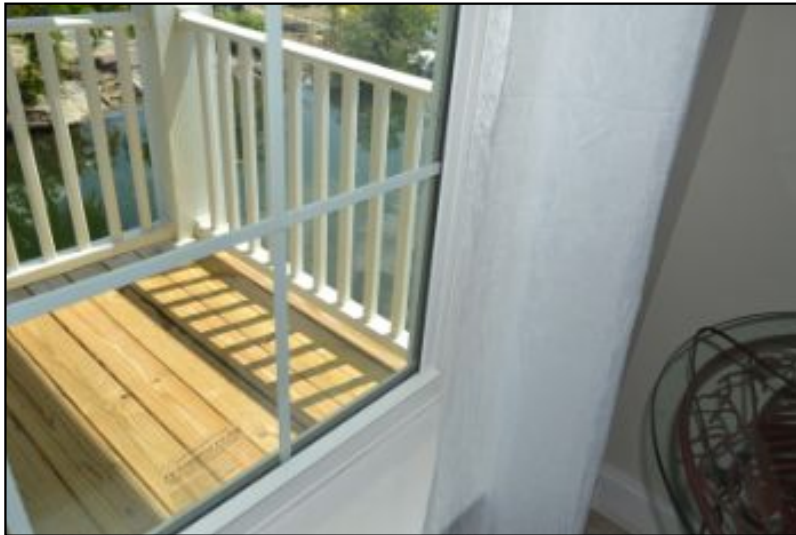
- One or more missing window screens observed.

Missing window screens at several windows

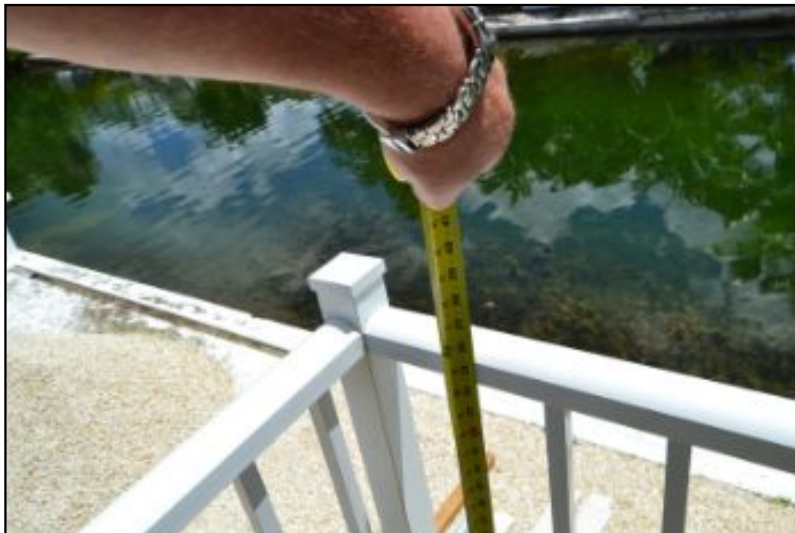
- Exterior railings were inspected and found to be in good condition.
- Exterior railings are 1/2" short in height.

Exterior rails are 1/2" low.

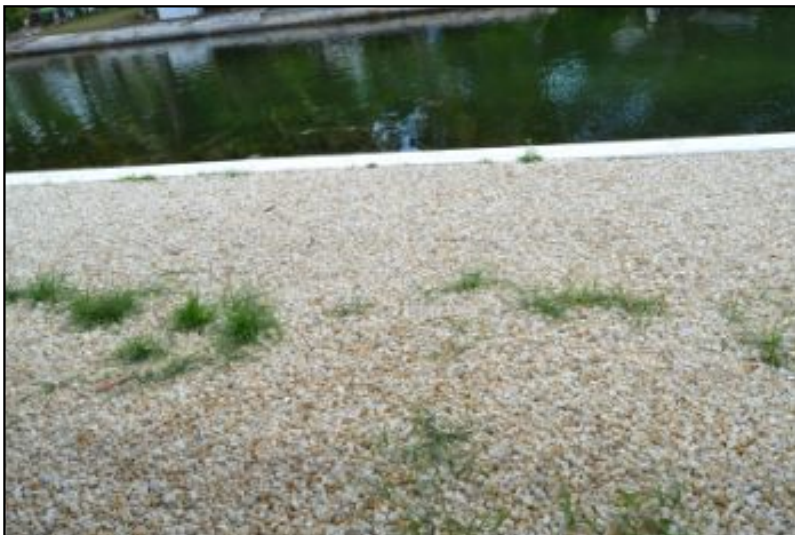
- The grading on the lot has an improper pitch or sloped toward the canal.

Improper grading toward the canal. Swale needed.
